## City of Morris LCCMR Activity #3: Thermal Imaging of Public and Residential Buildings

*Authored by Talitha Anderson, City of Morris Sustainability Project Coordinator*

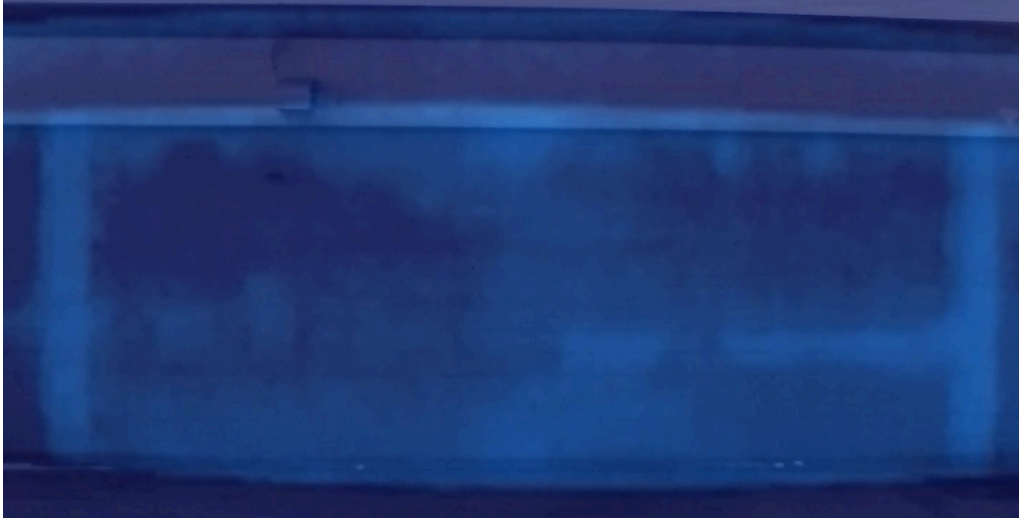
The Morris City Hall was the first building imaged as a part of this project. The exterior wall is brick. It has solar panels on the roof, which account for almost all of the building's energy usage. It is one story with windows located on the front and left side of the building. There are no windows along the back and right side. It was thought that there would be more heat loss on the roof, but the only heat loss was from the vents and air intakes in the center (**Figure 2**). Since the building was built, there was some interior construction to create closed offices out of an open space, and it is possible to see the office partitions on the thermal camera (**Figures 3, 4**).

**Figure 3: A thermal image taken by the drone of the back wall of the Morris City Hall** The thermal image shows lower temperatures in darker blues and higher temperatures in lighter blues. The interior office partitions are visible in light blue on the left and right of the image. The ceiling is also visible in light blue.

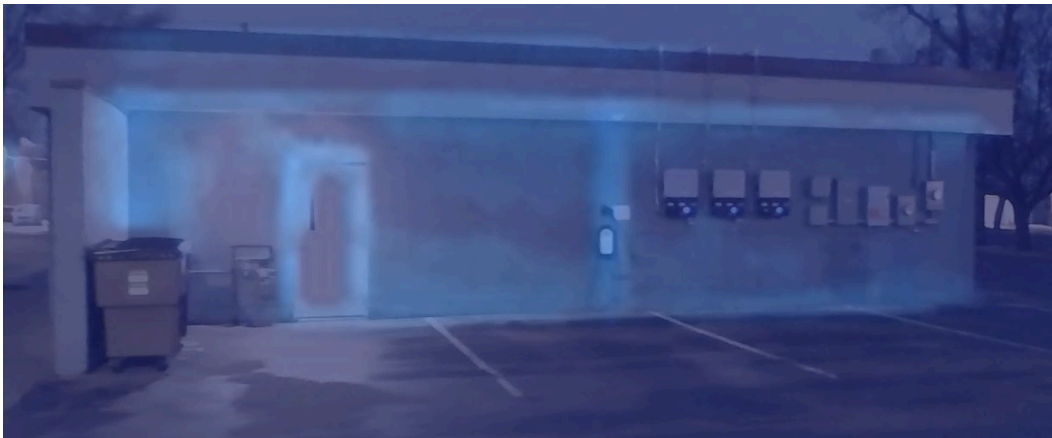
**Figure 4: A thermal image taken by the drone of the right wall of the Morris City Hall** The thermal image shows lower temperatures in darker blues and higher temperatures in lighter blues. The outline of the door on the left and the outline of the room partitions and ceiling are in light blue. The solar inverters are visible on the right side of the wall.

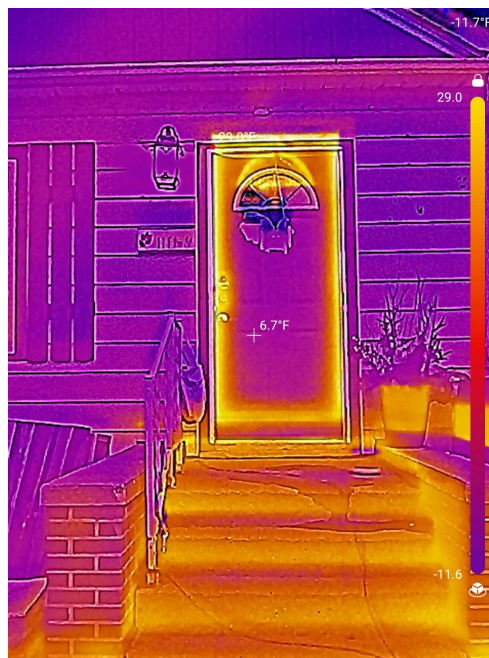
Built in 1959, it is a one story house with a half-finished basement. It is assumed that the house has fiberglass batts insulation in the walls and cellulose or fiberglass in the ceiling. The windows are 65 years old and the exterior walls are steel siding. The resident was interested in looking at their thermal footprint to find out if one could see the wintertime ice buildup inside the windows in the data, and is hoping to get new windows after going through the thermal imaging process. The biggest surprise for them was how much heat was leaking out at the door seals (**Figure 9**); they have mentioned to their landlord in the past that the door seal is falling apart and will keep advocating to have them fixed after seeing the energy loss. The resident will also continue to put up window plastic during the winter months.

**Figure 9. A thermal image of Resident #2's front steps and door** There is a temperature scale on the bottom with -11.6 Fahrenheit being the lowest (purple) and 29.0 Fahrenheit being the highest (yellow-white). The frame of the front door is a warm yellow while the door itself and the main house is a pink-purple.

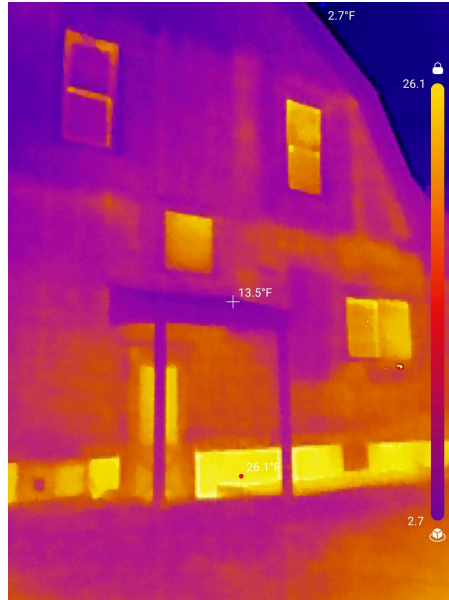
Built in 1908, it is a two story, 1,902 square foot house with an unfinished basement. There is no material insulation in the walls or roof, instead air gaps are used for insulation, with the exterior walls being made of wood, lathe, and plaster. Several windows were replaced in the bedrooms, dining room, and living room in 2009 when federal incentives became available, and the remaining windows are original. The resident was interested in looking at his thermal footprint to see if the improvements made to the house were detectable and if there were any areas that indicated a lot of energy leaking through heat loss as there have been some ice dam issues in the past. Through thermal imaging, he was able to see the impacts of replacing the windows by the difference in heat loss (**Figure 11**). One surprise was the insulated bedroom door at the back of the house because it was clear where the insulation stopped three quarters of the way up the door (**Figure 12**) - this was a pleasant surprise because it means the batting insulation works. Based on this, the resident is planning to put up more fiberglass batting to reduce heat loss and continue to replace old windows in the home.

**Figure 11. A thermal image of the side of Resident #3's home** The temperature scale on the right of the image shows the lowest temperature as 2.7 Fahrenheit (purple) and the highest temperature as 26.1 Fahrenheit (yellow). The upper left window is purple-pink color while the other three windows are shades of yellow. The upper left window is not original to the house.
